Service Bulletin 20

(a) Service Bulletin No.:	20
(b) Revision / Date	0/May 2014
(b) Title:	Replacement of Rego Female Hose Connectors
(c) Description:	Replacement of Rego 7141 couplings where the connecting nut and/or centre body are manufactured from brass

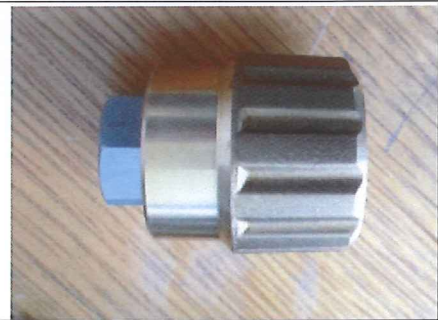
CH-0144-0001 Rego 7141 female coupling

1. Check the material of the centre body and back nut. If the material is obviously made of brass (yellow/gold) appearance a visual check is adequate, if the material is plated (similar appearance to chrome plate) a small area should be abraded with a file to check the substrate.
2. Any couplings with brass centre body and back nut should be replaced with an approved stainless steel alternative (CH-0144-0001). The maximum torque values are given in Cameron Balloons Maintenance manual i10-Amdt 3, Section 4.2.6.
